## Reuse and transformation Findings report

*KA13 - Kristian Augusts gate 13*

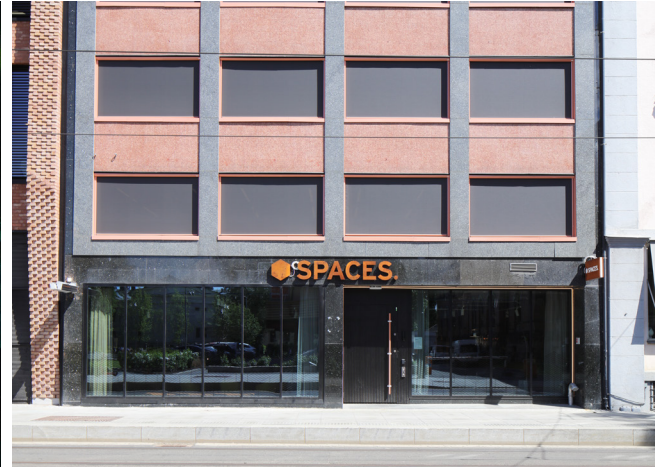
*The fitted glass panel facing out  
onto Kristian Augusts Gate.  
Photo Kyrre Sundal*

This type of glass façade is well suited for removal and installation.

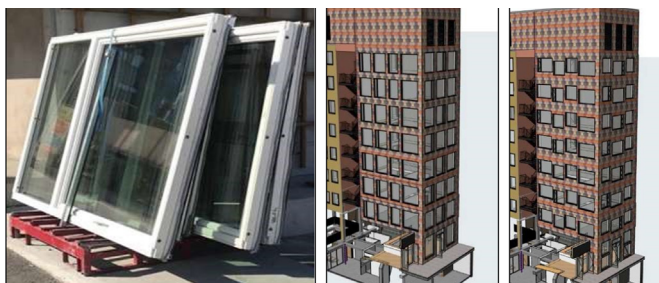
The windows were removed from a housing project in Kværnerbyen. Photo: Resirgel  
Extension façade, designed with 1) new windows, 2) used windows. Illustrations: Mad Arkitekter

- The windows were a bit wider than the optimal window width for this façade, such that the lathing/pillar construction was a little more complex/complicated than originally planned.
- RIB had to make new calculations for the pillar construction.

Haandverkerne were responsible for transport from Resirgel's warehouse and for the installation of the windows. The openable panes were allowed to block the opening function in order to ensure against opening/falling. 28 used windows were installed on floors 4 to 7 of the extension. There are 16 measuring 1,488 x 1,588 mm and 12 measuring 2,188 x 1,588 mm. 2 used windows (in other forms) were installed on the ground floor facing the back courtyard and in the meeting room on the first floor. Resirgel were able to provide the relevant FDV documentation and CE labelling for all of the windows. The windows can be dismantled and reused.

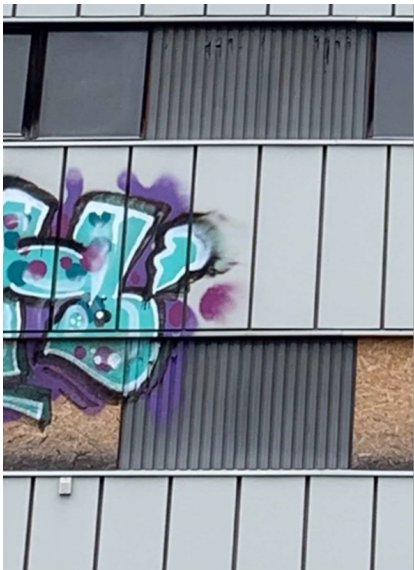
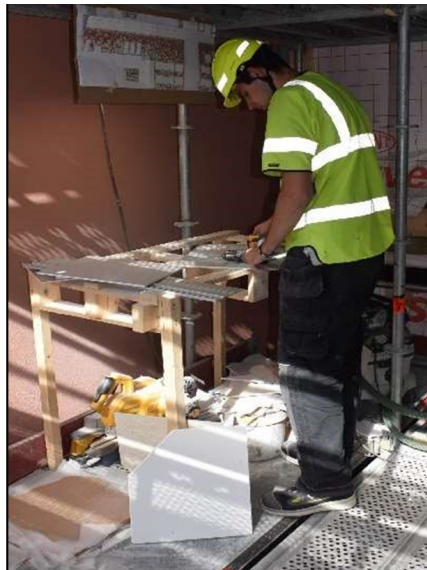
*Photo from the inspection, Oppsalhjemmet.  
Photo: Randi Lunke  
Cutting and installation work. Photo: Anne S Nordby  
Façade panels during installation. Photo: Randi Lunke*

After being cut down to size, the panels had to be sent for surface treatment and varnishing to protect the metal from rust. The backs of the metal panels were varnished and used as the front. The panels were temporarily stored at the construction site, Steni's own factory, Haandverkerne's warehouse and the plumber's workshop.

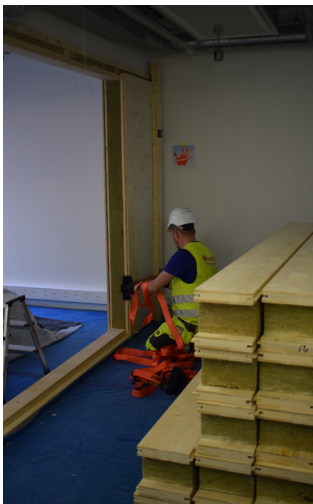
*Assembly of the Tewo walls.  
Photo: Anne S Nordby and Catriona Shine*

One consequence for the design, however, is thicker walls that take up a little more space. As this was a pilot project that included product development, it took a little extra time. On-the-spot modifications were necessary, and a number of fasteners had to be used (including screws for bases), for which solutions also had to be found. Strict sound requirements posed a challenge but were eventually met through the use of an extra layer of panelling, which in turn made the walls a little bit thicker. This could not be carried out in the factory and had to be implemented on site. The panel is attached to each element such that the elements are all still removable.

However, in the event of future reuse, they should be marked and reassembled in the same order, as the transitions between the elements have been sanded down. In total, approx. 160 m<sup>2</sup> of Tewo walls have been installed in KA13. The product has been installed for use as office partitions and as walls between meeting rooms and offices. The supplier, and the party responsible for the product, is Termowood. The product has been developed for easy assembly and disassembly. The product is new and comes with the necessary approvals.

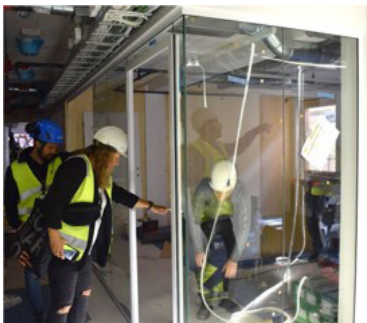
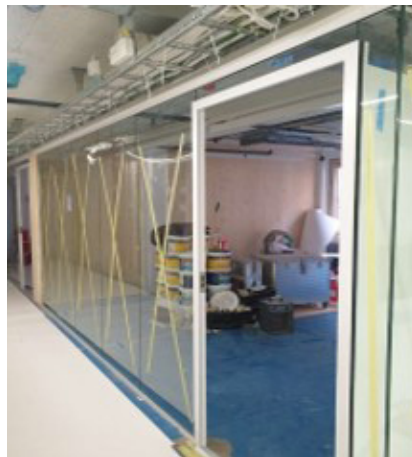
*Installing the glass fronts/office doors.  
Photo: Anne S Nordby and Noora Khezri*

CreoNordic procured 25 used office doors. They transported all of the used glass to their own workshop and prepared the glass there before its installation on site.

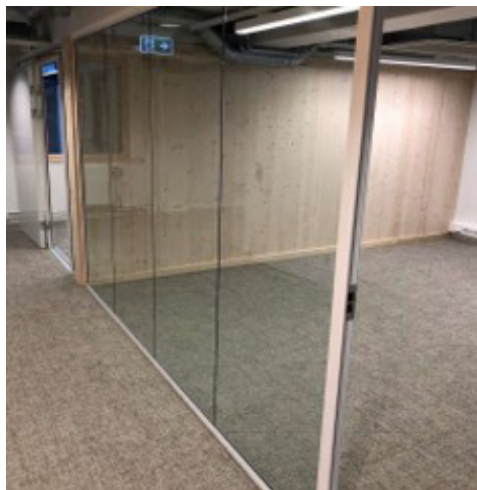
*Completed installed fronts.  
Photo: Rune Andersen*

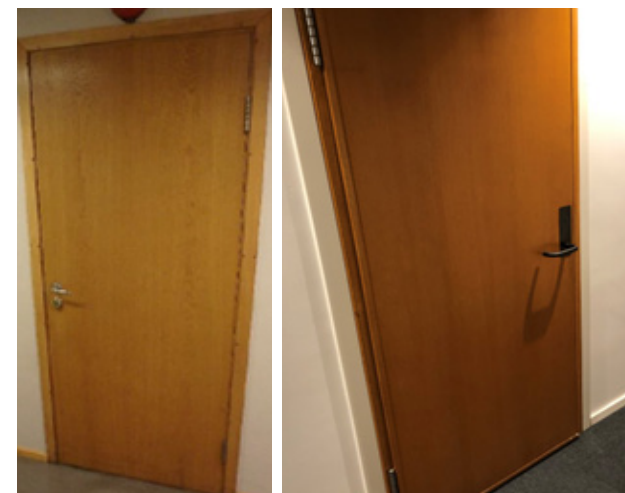
Oak doors from St. Olavsplass 5. Photo: Norconsult  
Reused oak doors fully installed in KA13.  
Photo: Rune Andersen

Fairly late in the project, oak doors were found in St. Olavsplass 5 (Entra) that were deemed suitable for use in the toilets of the existing building. However, the doors were of different dimensions, which had consequences for the project as all of the cut-outs had already been carried out on site and therefore needed to be changed. Upgrading the existing doors was a possible alternative, but this was decided against due to the uncertainty as to whether this would be good enough.

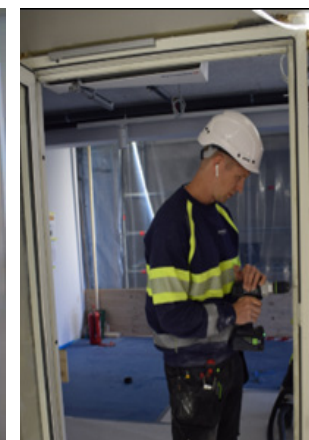
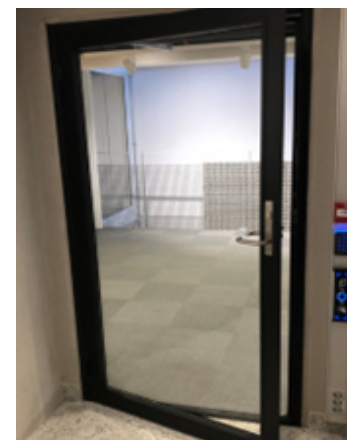
1–2: The door panel from DEG8 with the overlying glass panel removed and the door installed in KA13 with a new lock cylinder.  
Photo: Anne S Nordby

3: Used fire door, fully installed and varnished.  
Photo: Rune Andersen

Another issue was that there was a glass panel above the stairwell doors in DEG8, and it was only the doors themselves that we needed for KA13. As the fire doors into the stairwells were attached to the glass panel above, the steel had to be cut above the door if these were to be used in the project. It was also necessary to replace the lock plates. The question was whether the doors would then need to go through recertification after being modified so as to meet the fire requirements. We received an answer to this from the fire consultant at Fokus Rådgiving: The door supplier should be able to say whether the doors can be modified and whether they still hold their certification. In practice, these doors will probably be good enough with potential reinforcement above the door after the glass panel above them has been removed. The fire consultant may be able to confirm whether the product will be good enough, but that cannot be type-approved unless the supplier is involved. Fokus Rådgiving had come across modifications in the past – such as 6,000 doors for SIO, who had to change the lock plates – and felt that it was important to continue pursuing reuse on a general basis. As an alternative, it was suggested that the project apply for exemption from the City of Oslo Planning and Building Services in regard to the overall goal of resource efficiency.

Afterwards, we established email correspondence with the manufacturer, Norske Metallfasader in Stange. When asked if we could keep the fire certification after removing the glass panels, the answer was yes. We did not need to reinforce the frame, but it was important that the sealing between the frame and the door opening be done properly. By the time we received a response to this, we had missed the initial deadline for dismantling the components from DEG8. However, we were given an extended deadline in order to remove the fire doors.

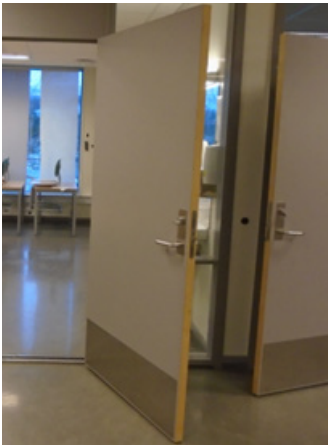
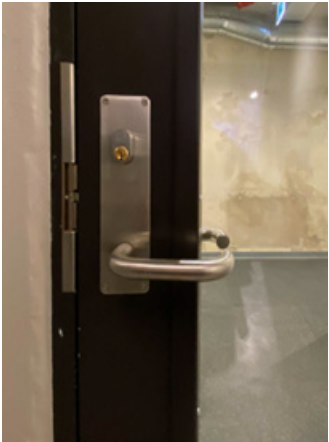
*Classroom doors, Refstad school. Photo: Anne S Nordby  
Used handles/signs from Refstad, installed on the new fire doors for  
floors 1–7 (west of the stairwell). Photo: Annethe Thorsrud*

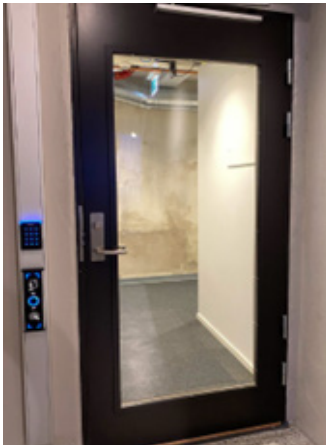
A total of seven stairwell doors from DEG8 were processed (glass panel above the door removed and the lock plate replaced) and varnished for use in the stairwell for floors 1–7. The used doors are installed on the east side of the stairwell. On the other side of the stairwell are the new doors we acquired. The used handles and escutcheons from Refstad school are mounted on the new doors.

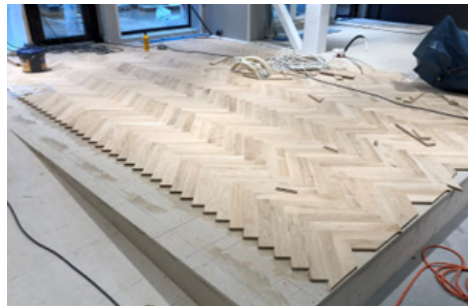
*The parquet slats during installation.*

98 m<sup>2</sup> of oak parquet was delivered for the project, but some materials were not usable and were eliminated along the way. The parquet was matte varnished after it was laid.

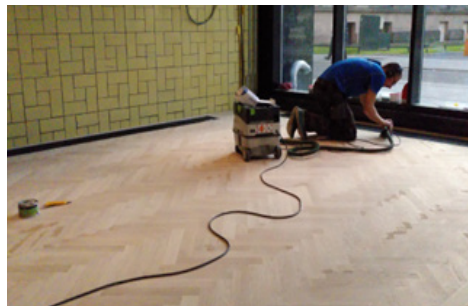
*Polishing the parquet. Photo: Anne S Nordby*

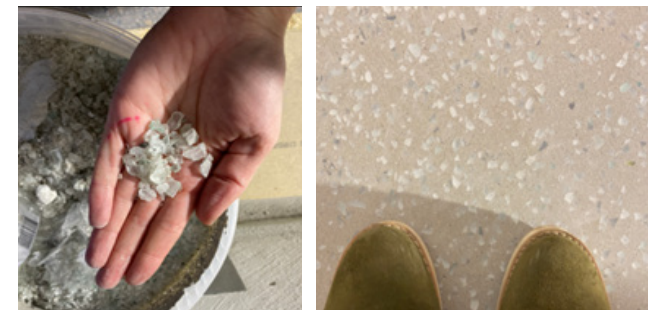
*Glass concrete: Concrete floor with recycled façade glass.*

Approx. 600 m<sup>2</sup> of concrete floor made with recycled façade glass was installed on the ground floor and in the basement.

Pounded glass (façade glass) was used in the floor screed for the ground floor and basement. The floor was supplied by Betotec. IARK visited Betotec's warehouse and assessed several samples that had been laid with a concrete and glass floor. Norsk Gjenvinning supplied the glass used in the floor screed. The glass came to Betotec in many different sizes, so these had to be separated and sorted before glass of the correct size could be thrown into the liquid floor screed. In total, around 600 m<sup>2</sup> of glass concrete was laid on the ground floor and in the basement, which used approx. 600 kg of pounded glass.

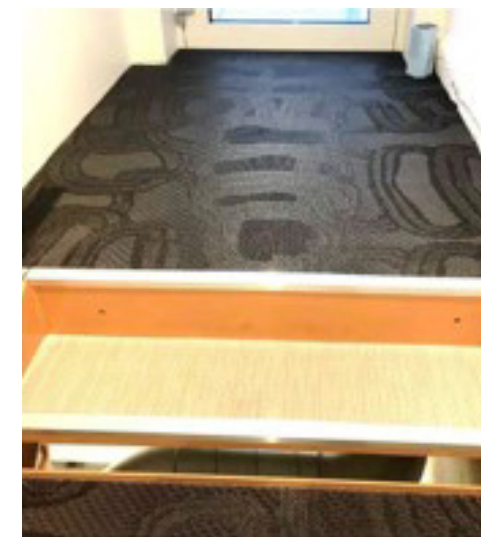
*Bolon flooring (vinyl) installed on the stairs.  
Photo: Annette Thorsrud*

The Bolon vinyl flooring was chosen for the internal staircase between the 7th and 8th floors, as well as for the landing and the pantry kitchen on the 8th floor. The covers came from stock remaining after the retailer Berg Studio renovated its showroom. IARK chose to use a light colour in the staircase for the first and last step. The reasons for this were an insufficiency of just one type of cover and this solution's ability to satisfy the markings required for universal design. So the path here changed a little along the way.

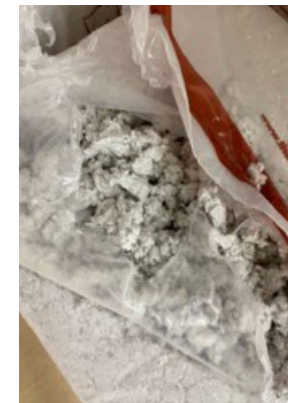
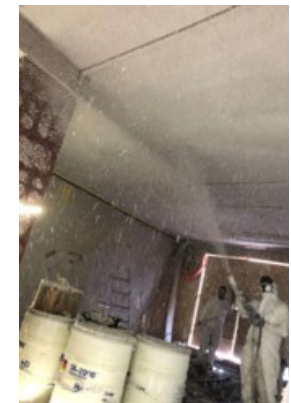
For the ground floor and basement ceilings, a recycled product was chosen: ThermoCon cellulose spray. The product consists of ground-up recycled paper combined with a water-based glue and is sprayed onto the ceiling. Specifications for installation in KA13 are ThermoCon SB. The spray is of a light grey colour and it is applied as a 40mm thick layer. In total, approx. 600 m<sup>2</sup> of cellulose spray was applied.

Raw material of ground recycled paper. Photo: Kristine Aassved Storeide

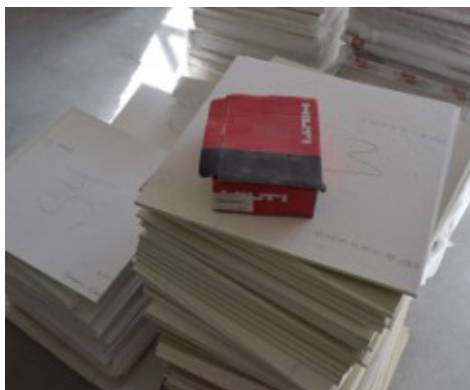
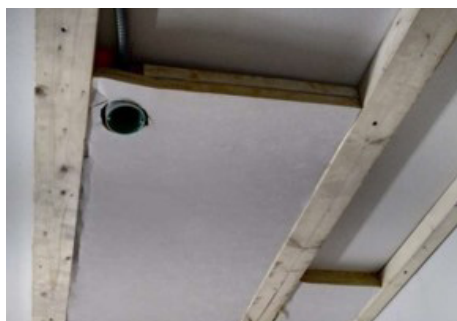
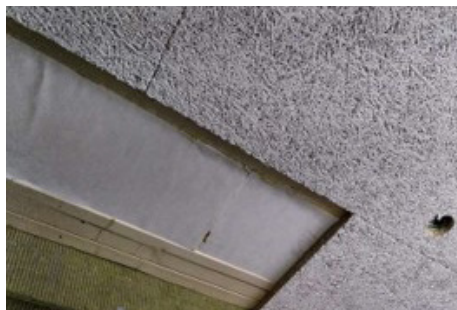
Mineral wool panels are a particularly common type of panel used in ceiling systems and can be found in a number of current renovation/ demolition projects. Haandverkerne dismantled 16,800 insulation panels (60×60 cm + some of 60×120cm) from various buildings. The depth of the panels was between 15 and 20mm. The majority of these were transported directly to the site as required and then installed. This was an easy job, but it did take time due to the numerous adjustments/cuttings that had to be carried out for the pipes and electricity.

*The mineral wool ceiling panels were used for sound absorption on top of the fixed wood wool cement panels. Photo: Anne S Nordby*

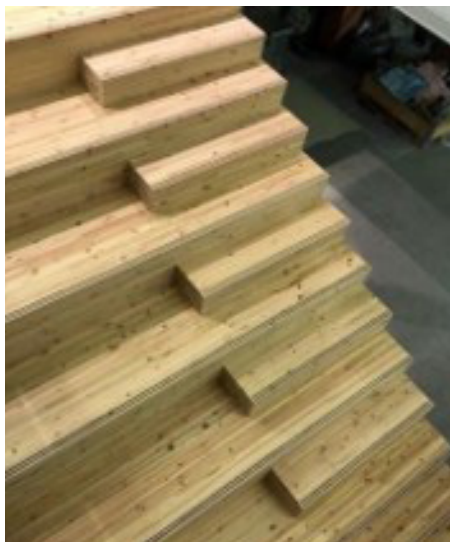
All of the wooden parts of the amphitheatre stairs were made of used materials sourced from Tøyenbadet. The underside of the amphitheatre stairs are clad with wooden slats sourced from the ceiling of the sauna.

*Completed amphitheatre stairs.*  
Photo: Rune Andersen

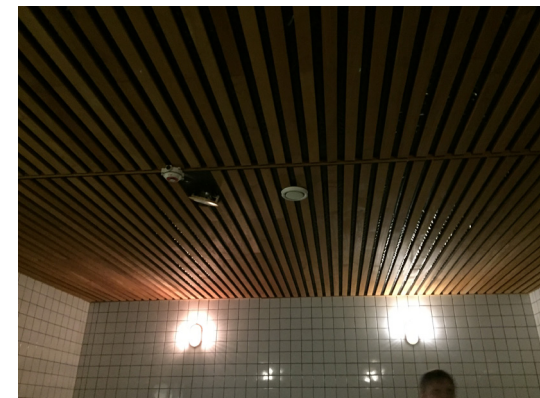
*Wooden ceiling slats, Tøyenbadet sauna.*  
Photo: Catriona Shine

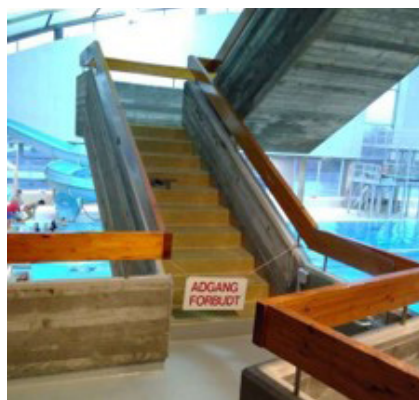
*The sturdy wooden handrails are from the Tøyenbadet railings.*  
Photo: Anne S Nordby

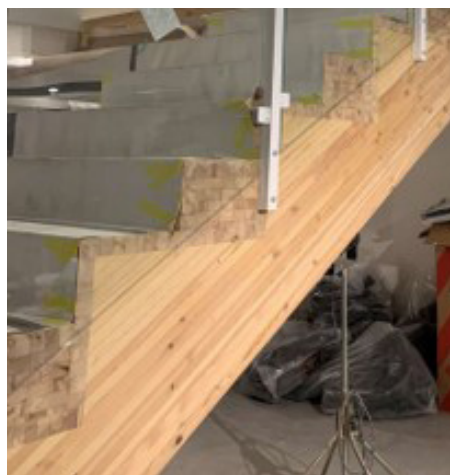
*Side wall with visible end wood.*  
Photo: Randi Lunke

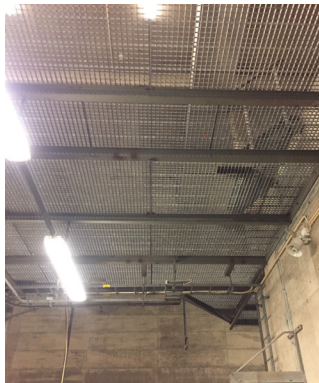
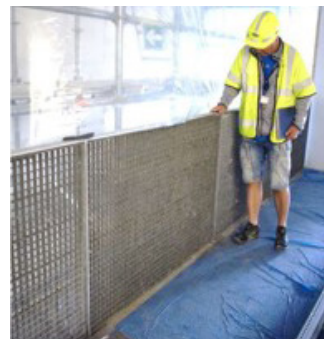
Suitable mesh grids were found at Tøyenbadet, where they were in use as flooring in the mezzanine of the technical room. The mesh grids' transparency was suitable for their use as railings: the mesh width came to 35×35, with the profile height at 25mm. 38 panels of 990 × 1,490 mm were removed from Tøyenbadet by AF Decom.

1–2: Mesh grids were used as flooring in the technical room at Tøyenbadet, which is where the measurement took place during inspection. Photo: Catriona Shine.

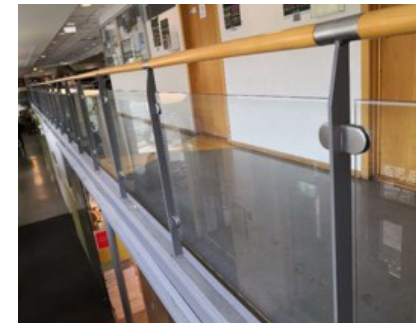
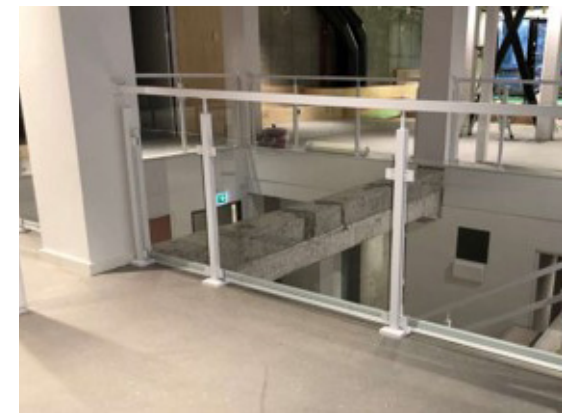
Haandverkerne dismantled the panels, and CreoNordic carried out the installation. Used glass has been installed in the new steel profiles. The adjusted panels are made of new glass.

Glass railings, St. Olavs plass 5. Photo: Norconsult  
Glass panel with new frames in KA13. Photo: Rune Andersen

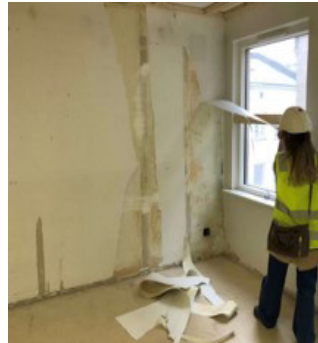
*The existing wall was cleaned, sanded down and dust-bound.  
Photo: Rune Andersen and Anne S Nordby*

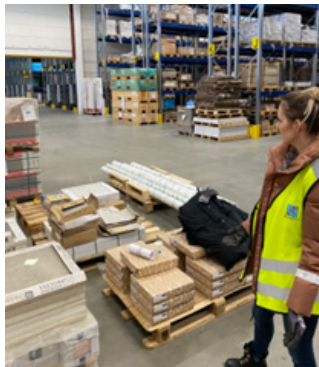
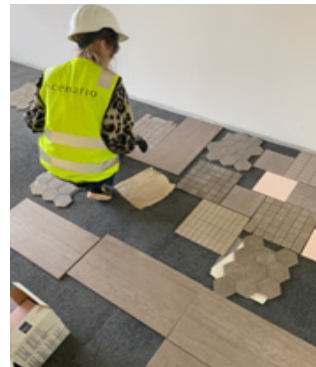
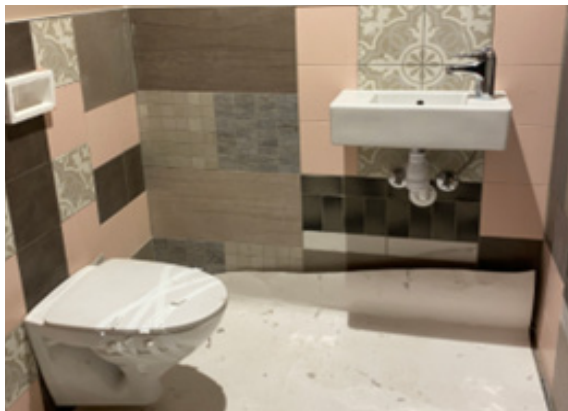
1-2: Selection of surplus tiles and test laying.  
Photo: Kristine Aassved Storeide

3: Completed mosaic of surplus tiles in the toilets.  
Photo: Kristine Aassved Storeide

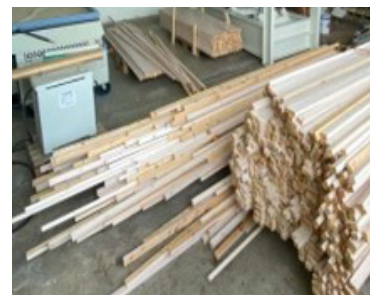
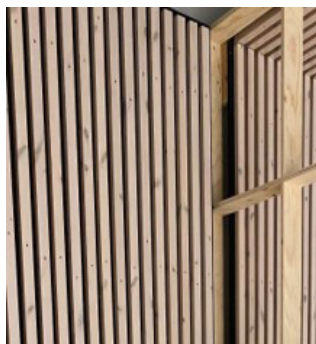
Installation in KA13. Existing screw holes that were kept. Photo: Kristine Aassved

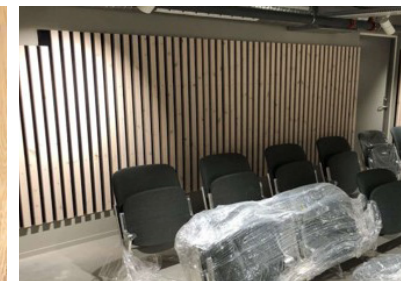
Completed booths and cladding made of used slats on the back wall of the cinema room. Photo: Rune Andersen

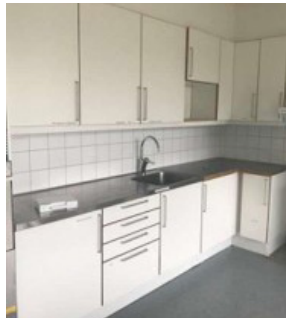
*The kitchen units/fittings from Lambertseter sykehjem.  
Photo: Rehub/Rambøll*

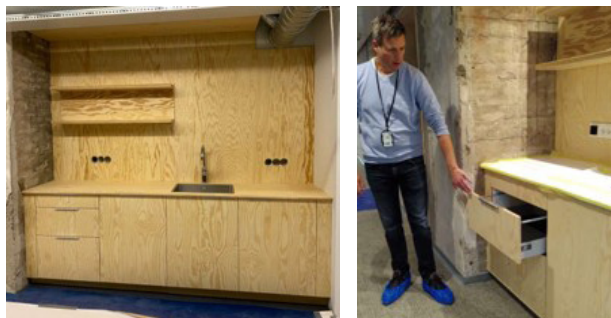
LUN manufactured new fronts, linings and bases in 15mm plywood to adhere to the sketches provided by IARK. The original plan had been to reuse plywood for the temporary barriers set up on the construction site, but this was too thin and unstable for use in this way. LUN also produced the worktops, backboards and wall shelves, as well as the ceiling components above the kitchen. The plywood used for the fronts was matte-varnished and will withstand the usage of the premises well.

*Fully installed cabinets with new fronts made of 15mm plywood.  
Photo: Lars Ulrich Nielson/LUN and Anne S Nordby*

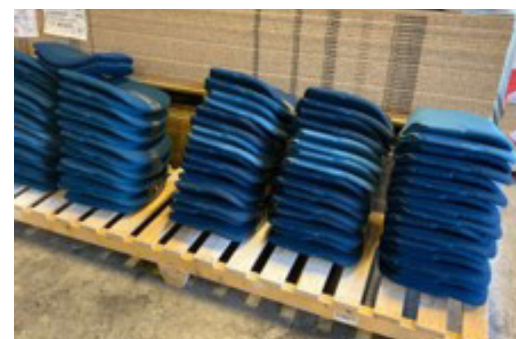
The Østheim contractor dismantled 40 seats, which were sent to the furniture upholsterers (LUN) to be reupholstered. The seats were of varying quality and size. This was addressed by placing the highest seats at the back of the room, and the existing steel rods were cut down in order to fit the new arrangement. It was decided not to use the attached folding tables. The seats and backs were given new upholstery and textiles. The chairs were given a little extra padding in both the seats and the backs for increased comfort.

*Reupholstering of the auditorium chairs by LUN.  
Photo: Lars Ulrich Nielson*

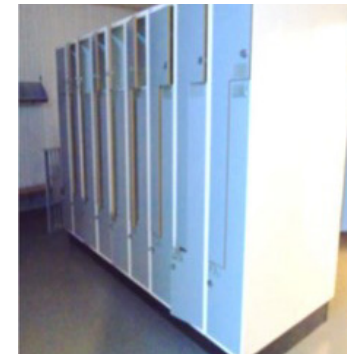
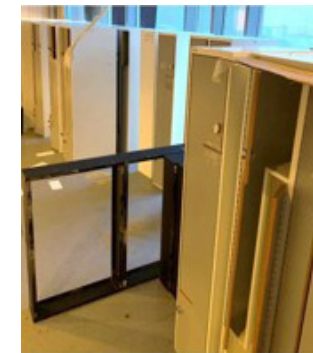
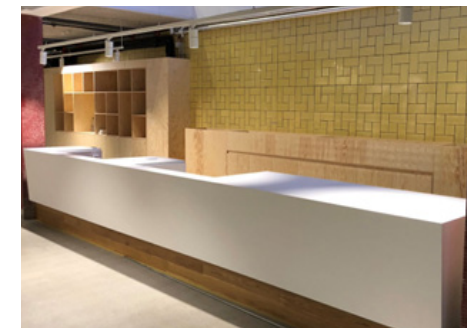
1-2: The lockers in the changing room at Refstad school and in storage.  
Photo: Anne S Nordby and Randi Lunke  
3: Corian reception desk.  
Photo: Rune Andersen

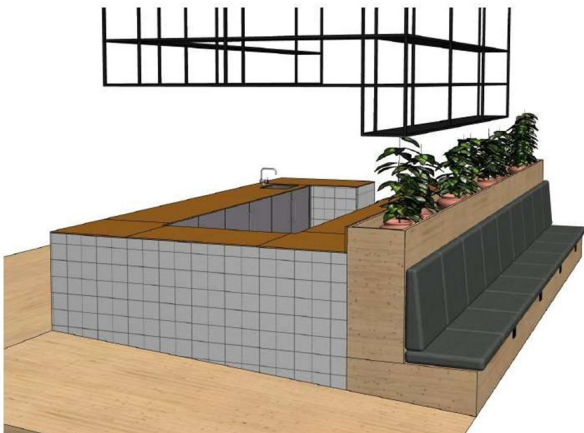
#### DESCRIPTION OF CAFE COUNTER:

The exterior cladding of the café counter is made of ceramic tiles from Bergersen Flis' surplus stock.

*All pine board is to be priced as pine plywood, white pigmented and matt lacquered. It is desired that all Pine board is to be sourced from reuse sources, and can vary in finish and size.*

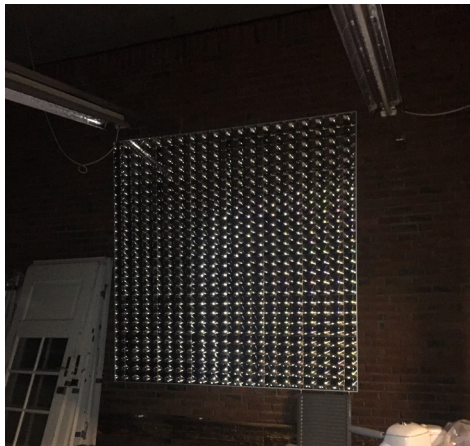
*The reflectors were dismantled from the ceiling in Tøyenbadet, stored and eventually mounted to the light shafts at KA13.*

The brackets were shortened so that the reflectors could be attached closer to the wall and be tilted up and down for the desired effect. No repairs were required for the reflectors. The reflectors were temporarily stored in the Posthuset building after being dismantled from Tøyenbadet.

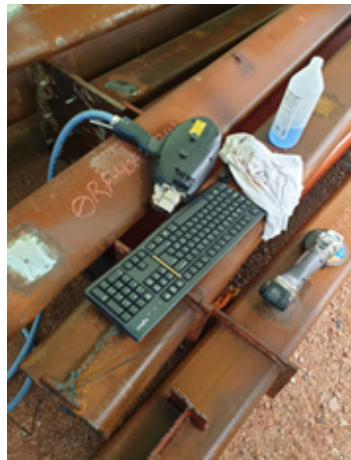
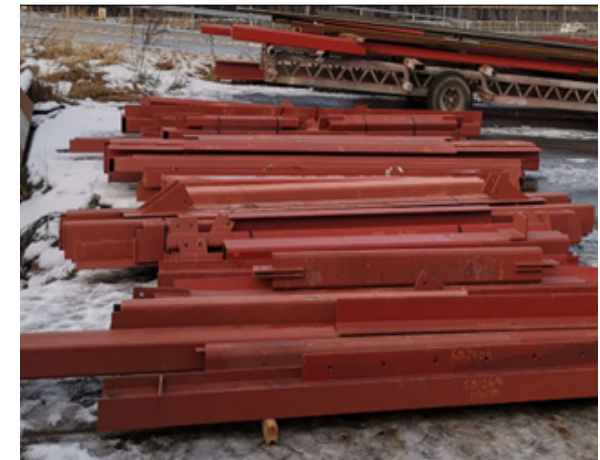
*Steel storage. Photo: Stokke Stål*

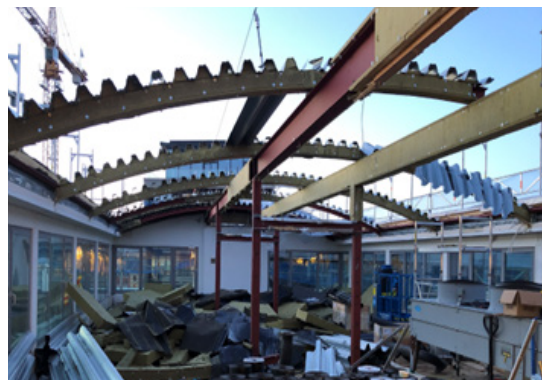
*Dismantling of steel in Dronning Mauds gate 1–3.  
Photo Thomas Lindseth  
Analysis of chemical compositions with an  
OES-spectrometer. Photo: Stokke Stål*

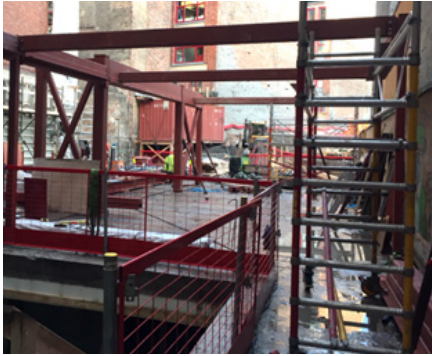
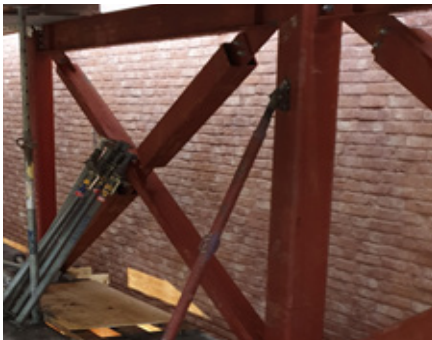
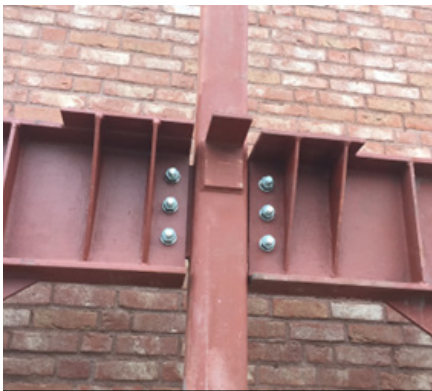
Installation of the used steel on site.  
Photo: Stokke Stål

The I-profiles and H-profiles were originally intended for use as support beneath the concrete deck, but the height of the beams reduced the light coming in from the windows. Hat profiles were therefore used, which are installed into the same horizontal layer as the hollow core slabs. I-profiles and H-profiles are advantageous in that they can be bolted into columns, but bolting is not common for junctions between hat profiles and columns. The bolt solution was therefore designed and implemented only for the rear wall in axis A, which has no windows.

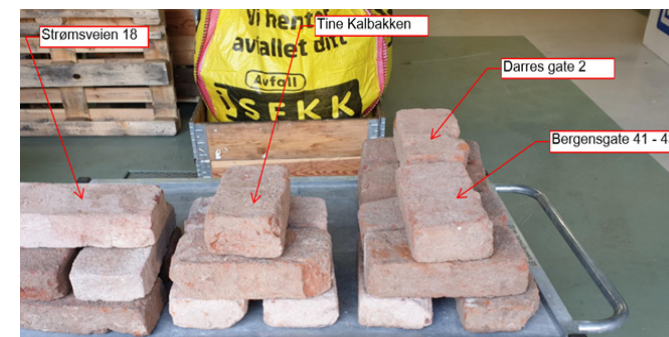
Bricks from four different buildings. Photo: Øst-Riv

Whole bricks were picked from piles following the demolition, then shaken in screeners to remove the coarsest from the mortar. Fine cleaning was then carried out with a hammer for the stacking of pallets. The lime mortar was porous and easy to remove. An inspection was also carried out in connection with the implementation of this, in order to check that no damage had been caused to individual stones. Stones of possibly more recent formats were removed from the batch.

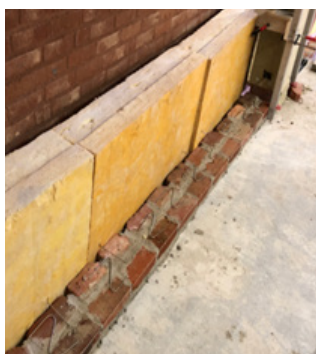
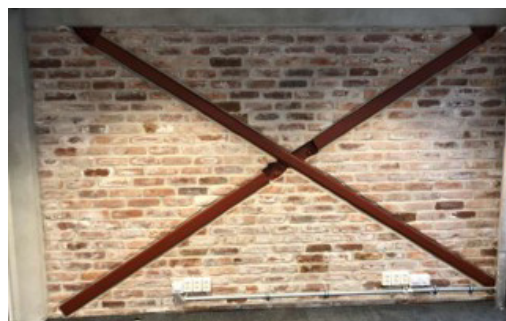
Construction and completed fire wall. Photo: Rune Andersen

A brick wall one-stone thick was built diagonally between the columns, and the wall sits flush with the steel exterior. The exposed steel was protected from fire, but according to RIBr, it was not necessary to plaster the brick wall for fire safety purposes. On the outside, facing the neighbouring buildings, the wall was built with an externally suspended stone wool panel.

A type of mortar based on natural hydraulic lime was used: Mørtel-NHL 3.5 0–4 mm. Lime mortar is weaker and more elastic than cement mortar. If lime mortar is used in the masonry, then the bricks are removable. This means that the bricks can be used in the next round of renovations too, should it be necessary to demolish the wall.

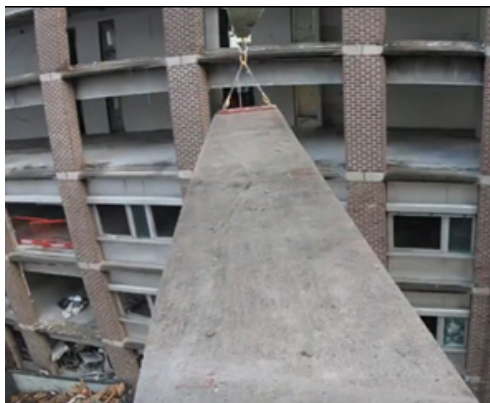
*Hoisting the hollow core slabs out of R4.  
Video clip from NRK*

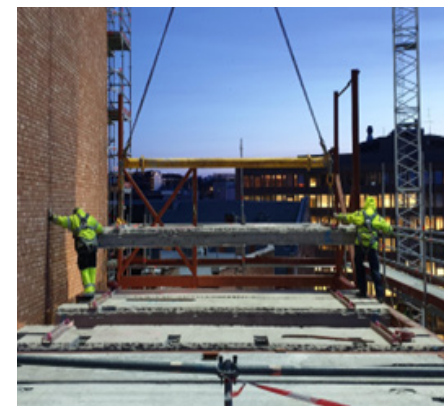
*Lifting the hollow core slabs into place.  
Photo: Mattias Johnsson*

The hoisting was carried out quickly and without any problems. Øst-Riv was responsible for transporting the slabs via the warehouse in Follestad to be prepared for installation (cleaning the grout off and cutting them to the correct length) and then transporting them onwards to the construction site for installation. The hollow core slabs use traditional fixings. They are located on the hat profiles facing the façade and on the H-beams facing the other sides. Joint grout was used between the elements.

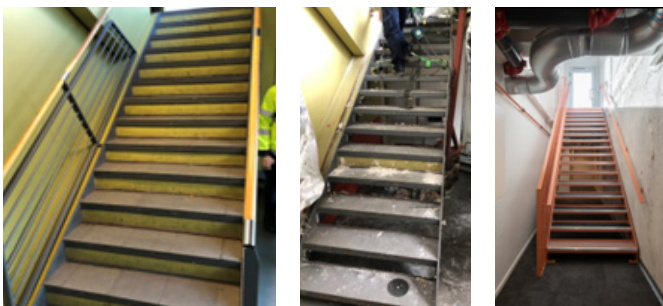
1–2: Stairs before and during dismantling from St. Olavs Plass 5.  
Photo: Rune Andersen

3: Reused staircase, processed and installed in KA13. Photo: Kyrre

A new staircase was needed from the 7th floor to the roof terrace on the 8th floor. Two steel staircases of different widths were found at St. Olavsplass 5 (Entra) and assessed. One of these fit well in regard to width but was a little too short. Stokke Stål dismantled and transported the staircase to Stokke for cleaning, modifying, sandblasting and varnishing. In order to fit as needed in KA13, the stairs were fitted with four extra steps at the top. The staircase was then painted a new colour, and a new handrail was made.

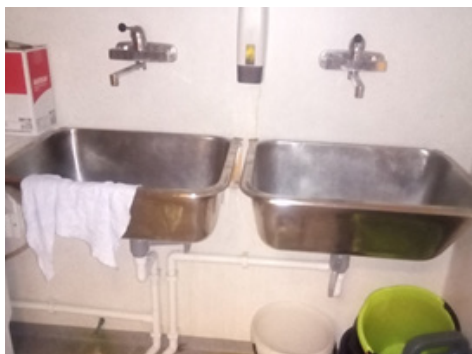
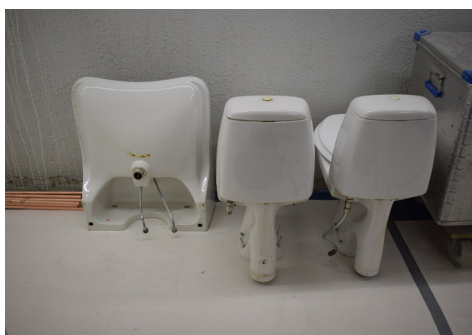
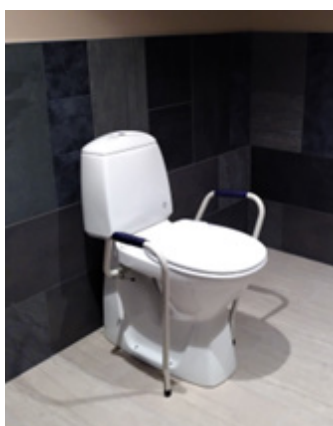
*The sanitary equipment in its original building, in storage, and installed in KA13.  
Photo: Anne S Nordby*

The sanitary equipment was installed in the usual way and is generally removable.

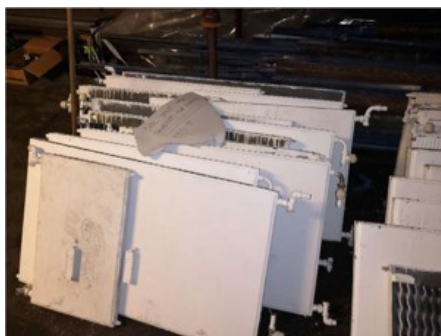
*Storage prior to flushing and compression testing. Photo: Anders Sand*

The quality assurance of the existing radiators in KA13 was carried out with compression testing. The exteriors of the radiators were further processed through dry ice blasting at the workshop, which was followed by painting and a change of valves. The newer radiators from U2 and Refstad just had to be flushed through, then some were painted while the rest kept their original colour. Some of the radiators were not sufficiently well packaged or taken care of after the surface treatment and thus some sustained damages. These had to be repaired on site.

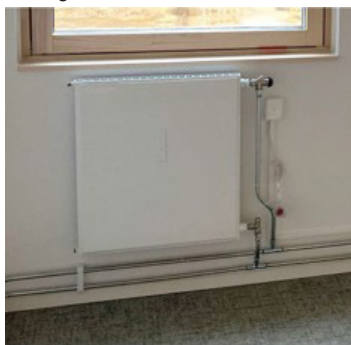
*Completed installation after processing.  
Photo: Randi Lunke*

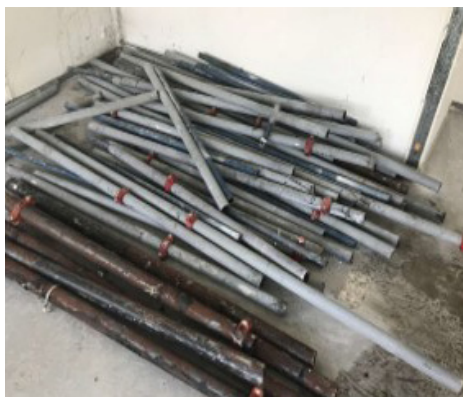
Used sprinkler pipes, dismantled from U2.  
Photo: Christoffer Siopan Engtrø

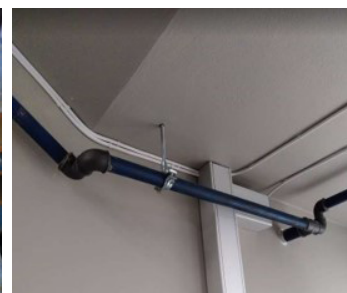
Used sprinkler pipes, completed installation. Photo: Anne S Nordby

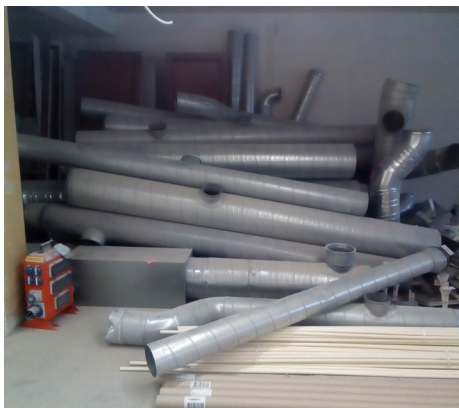
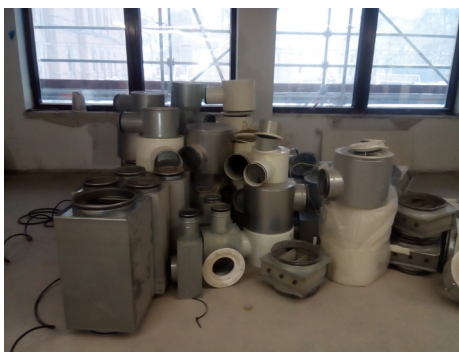
*Used, round ventilation ducts and duct elbows – dismantled and roughly sorted in KA13.  
Photo: Anne S Nordby*

- All straight and circular ducts were sorted and cut into “full reusable lengths”. Number and length were recorded. The cut-off was disposed of in the metal waste.
- All elbows without any damage were put aside. Elbows that had sustained damage and that were not considered suitable for reuse were disposed of in the metal waste.
- We did not have use for square ducts. Not considered to have value for other projects. Disposed of directly as metal waste.
- Other sorted equipment. Equipment that had dents etc. separated from that which was “whole and undamaged” (i.e. none of this was immediately disposed of).

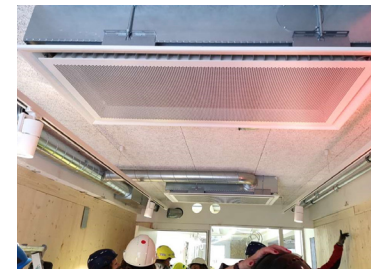
Complete installed beams in the test room of KA13.  
Photo: Christoffer Siopan Engstrø

The chilled beams for comfort cooling were acquired from Dronning Eufemiasgate 8 (DEG8). RIV observed that this was the right type for usage for KA13 and assessed the quality of the chilled beams as good as new. Type: Parasol 1200, Swegon: 1192A-HF.

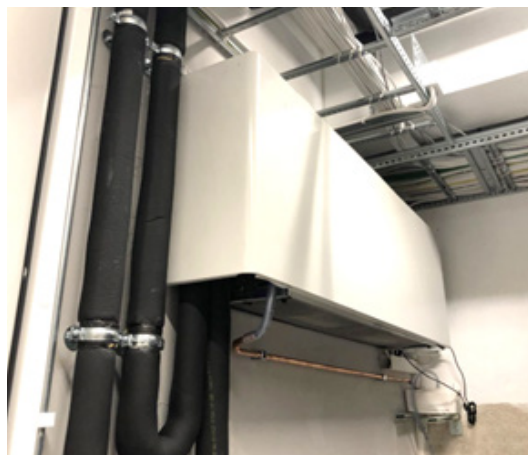
*The reused fan coil unit installed in the computer room in the basement. Photo: Rune Andersen*

Energima did a visual inspection of the equipment and assessed that both fan coils were dirty and showed signs of poor maintenance in relation to changing/cleaning the filter. This often affects the fan, which will then operate with too high a pressure drop. In turn, this significantly reduces the lifespan of the ball bearing, meaning that the condition was uncertain. The elements were also too large to be placed as had been drawn up and thus had to be placed on the wall. It was eventually decided that one (which was in better condition) could be used in the computer room and that the other would be kept as a spare in case the first required parts.

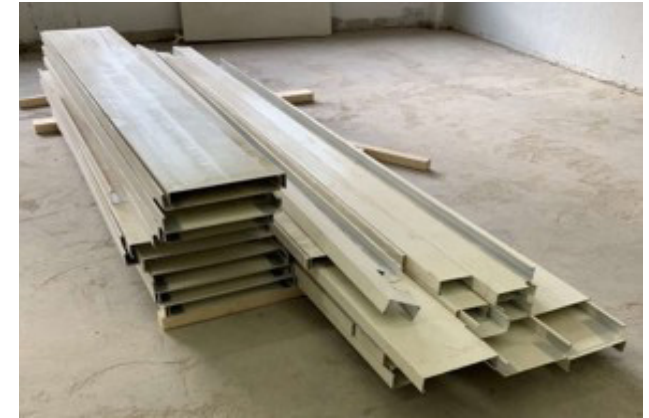
Cableways after dismantling. Photo: Randi Lunke

As a result, a number of cableways were thrown away. Some of the cableways from KA13 could, however, be used in the toilet corridor. A few metres with a width of 10cm were reused on each floor. A total of 23 pcs. around 2.5m long were found to be reusable.

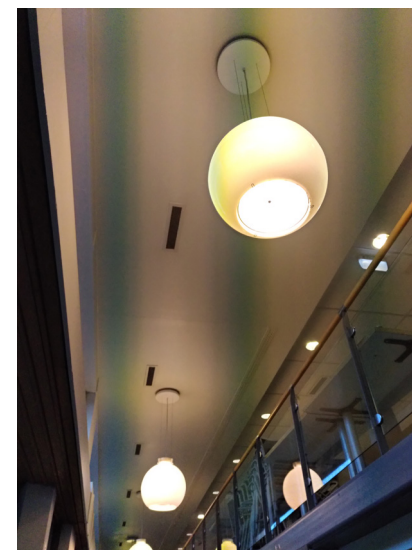
The lights were to be used as accent lighting and had to be dimmable. This required an extra module. A total of 6 lights were remodelled by Lighthouse, and the new materials used inside the lights is documented below.

*Dome ceiling lights from St. Olavs Plass 5.  
Photo: Anne S. Nordby*

Later, 10 large glass domes/pendants were found in St. Olavs plass 5 (Entra) and IARK thought they were well-suited for the reception in KA13. However, there were 3 fluorescent tubes in each bulb, so reusing them required remodelling. An electrician (Kontakt Elektro) checked whether the inside could be replaced. Kontakt Elektro assessed that it was safe to remodel and carried out the first experiment with one of the ceiling lights, installing an LED light chain in the centre of the dome. The result was assessed along with Scenario and approved by everyone involved. The remaining lights were then ordered from St. Olavs plass 5 and remodelled. Unfortunately, four glass domes cracked during the dismantling procedure, as they were old and could not withstand much. It didn't take more than a small crack before it all went downhill.

dome ceiling lights from St. Olavs plass 5 were remodelled with a new LED system for use in the reception. These individual projects were not necessarily profitable individually, but the demand for these services could be the prelude to the establishment of new businesses and business models that better align with circular thinking. The environmental benefits of such measures are enormous in themselves, but projects such as KA13 are also expected to have a significant socioeconomic impact by creating local jobs through the reuse of materials. While the socioeconomic impact is not a part of the thesis, the topic should nonetheless be a central focus in future reuse projects.

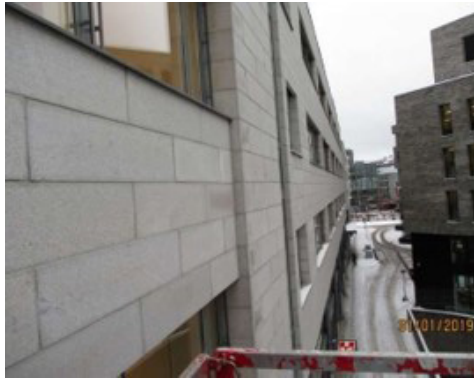
*Façade in Drammensveien 134.  
Photo: Noora Khezri*

Raised terrace floors are usually made with stone slabs 3cm thick. This matches the ordinary stone cladding used on façade, which is also often 3cm, so this type of stone was searched for. Entra's building at Drammensvn 134 in Skøyen had exactly this type of stone facing in granite, and this stone façade was ripe for repair/demolition due to defects in the fastenings and the danger of it falling. The stone slabs therefore could not be used on the façade. The fact that the stone slabs had to be dismantled came up conveniently and a portion of the stone slabs were reused in KA13.

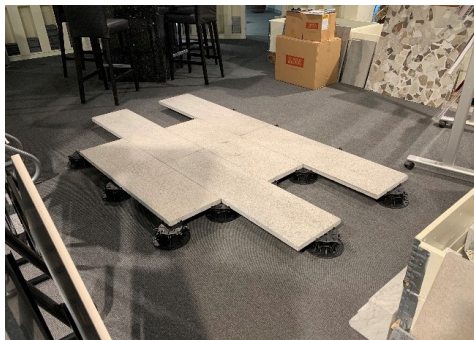
*Ellingard Naturstein testing the floor.  
Photo: Rune Andersen*

The stone slabs were used as flooring on the 1st floor roof terrace. The roof terrace functions as a blue roof, and the stone slabs thus lie/rest on the pedestals. The pedestals are height-adjustable and have an adjustable head so that they can be adapted for unevenness and differences in height. It is also easy to readjust their height with a screwdriver in the opening between the slabs, even after they have been laid. Ellingard Naturstein carried out the work, and a test floor was set up beforehand, which was inspected and approved. Placement of the pedestals was planned so as to ensure several things, such as the covering being locked into the walls. A check was conducted to ensure that the 3mm gap opening between the stone slabs allowed enough space for water to drain through to the roof below. The calculation was carried out by Multiconsult.

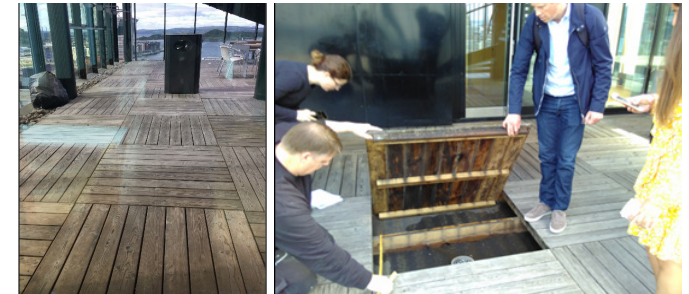
*Wooden decking, DEG8. Photo: Noora Khezri Measuring during the inspection. Photo: Anne S Nordby*

The wooden decking (slats) was found during an inspection of DEG8, then dismantled by Haandverkerne. These were used for the 9th floor roof terrace. The slats were temporarily stored at Haandverkerne's own warehouse in Sem, Asker. The best slats were chosen and the surface then painted in a shade of grey. Ellingard Naturstein carried out the task of adapting the wooden slats and installing them on the pedestals the same way as the roof terrace had been installed on the 2th floor, as this also functions as a blue roof.

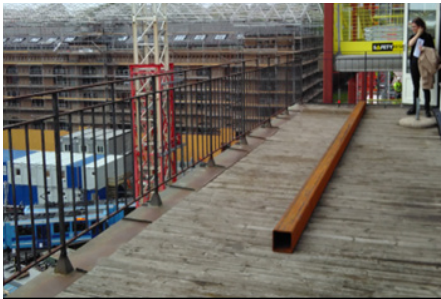
*Railings on the 8th floor, original situation.  
Photo: Anne S Nordby*

The existing railings around the 8th floor roof terrace were preserved and upgraded according to TEK17 requirements by doubling the density of the slats. This was assessed by ARK and carried out by Jomek at the workshop.

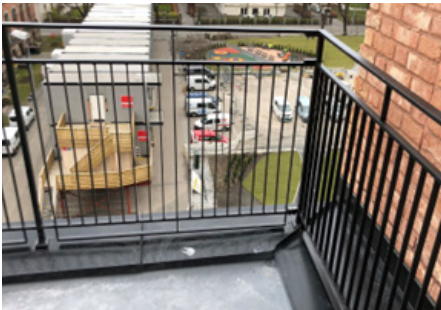
*Completed railings. Photo: Rune Andersen*

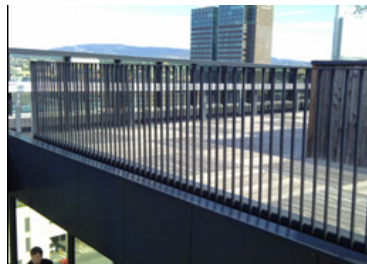
*Railings from the roof terrace in DEG8.  
Photo: Anne S Nordby*

The railings on the 2th and 9th floor roof terraces were reused from DEG8. Jomek and Haandverkerne carried out this work. All of the railings were used as they were and are still reusable for another potential round of reuse. The parapet and flower boxes were prepared with fixing brackets so that the railings could be reassembled at the same angle as originally fitted to the bottom of the railing. It was decided to attach the railings on the 2th floor to the outside of the parapet, which entailed extra challenges regarding the roofing around the attachment point and more complicated adaptation brackets, meaning that RIB had to get involved.

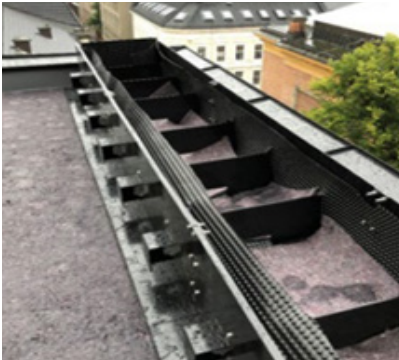
*The planters before filling with soil.  
Photo: Janicke Ramfjord Egeberg*

A search for used steel panels was carried out for the planters, but no suitable panels were found. Steel for the planters was instead supplied by Nordic Steel and assembled by Bergknapp, then delivered to and installed in KA13. The panels for the planters are comprised of 80% recycled steel.

The sketches from LARK were further developed by Bergknapp and Nordic Steel, who prepared the production sketches. The components were then screwed together, so it would be easy to dismantle and possibly reuse the products later.

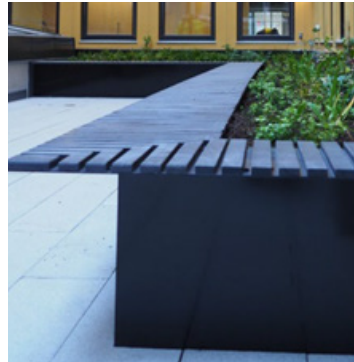
*The seat panels made of recycled plastic are mounted onto the steel panels. Photo: Janicke Ramfjord Egeberg*

Hardwood slats were sought for the benches but nothing suitable for an outdoor environment was found. Instead, Bergknapp was able to deliver slats of recycled plastic in the form of panels that were then cut into slats. The slats consist of 100% recycled materials. The components were screwed together, and the benches are removable.

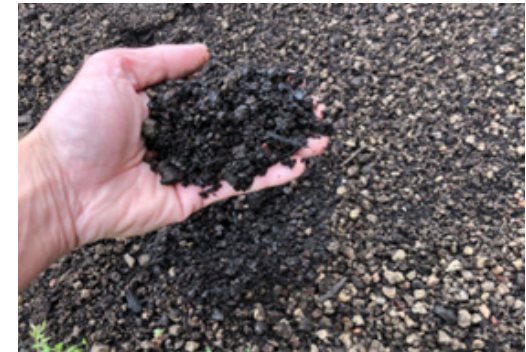
*Recycled soil from Bergknapp. Photo: Rune Andersen*

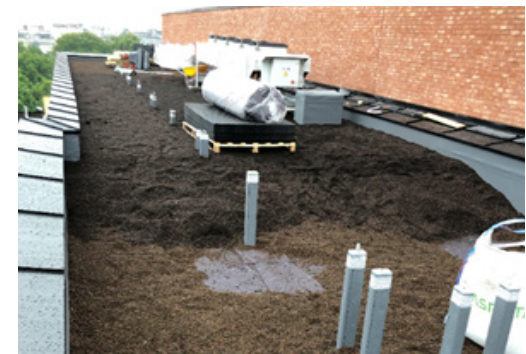
*Recycled soil placed on the roof.  
Photo: Rune Andersen*
